Regional Incident Survey Team (RIST) Report

Eastern-0904-Transportation

Cargo tank truck, believed to be an Motor carrier (MC) 306

Ethanol, UN 1170

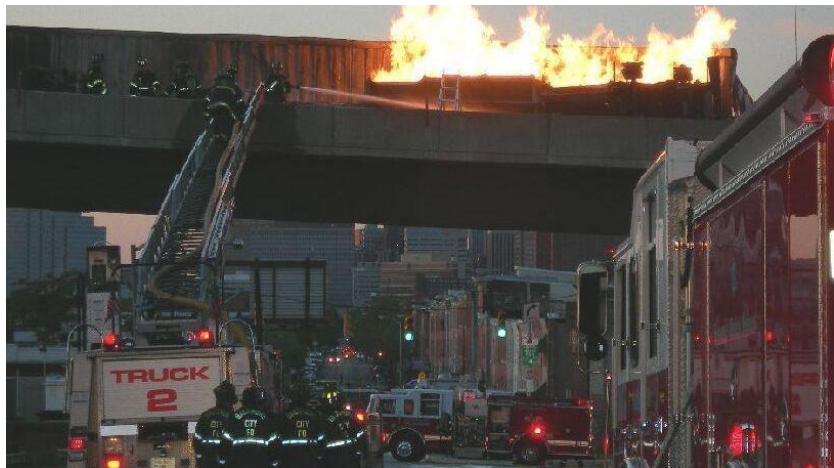
On a late spring afternoon, in an eastern United States community, emergency personnel responded to a report of a tanker rollover on a major interstate on-ramp.

another company running over their hose. The ARFF unit applied their aqueous film forming foam (AFFF) without success and then attempted to extinguish the fire with their Purple-K dry chemical agent. The application of the Purple-K helped to knock down the fire but when the supply ran out, the fire re-ignited. Additionally, there was drop-down fire off the overpass that set several vehicles on fire on the road below.

The fire was ultimately extinguished using two hand lines flowing AR-AFFF.
