# Regional Incident Survey Team (RIST) Report

## Eastern-0902-Transportation

Transportation

Motor carrier (MC) 306

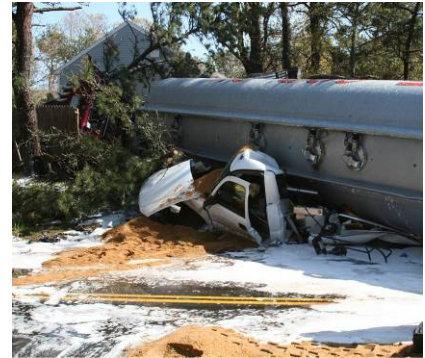
On a late, spring afternoon in an eastern, rural United States community, an MC 306 carrying approximately 30.28 kl (8,000 gal.) of home heating fuel placarded 1203, was struck by a small pick-up truck that ran a stop sign at a four-way intersection. The local weather conditions were clear skies, temperature at 15°C (59F°), relative humidity at 29 percent, and winds out of the NE at 21 kph (13mph). At 1501 hours, the local 9-1-1 received a report of a tractor trailer rollover with unknown injuries. The caller also stated there was a chemical leaking from the tanker.

Hazmat size-up reported the following: remains of white pick-up is 75 percent covered by the tanker, the front # 1 compartment is leaking in the lower corner into sandy soil, and the rear #5 compartment is leaking in the lower rear corner. Early estimates were that each puncture was leaking 37-56 liters (10-15 gallons) per minute.

On scene operations began by foaming the leaking areas and extricating the occupant of the pick-up. Other crews attempted to control the leaking fuel with wooden wedges, plugs, inert clay and air bags with little success. Local public works personnel arrived and began building a retention area downstream from the tanker and diverted flow away from wetlands.
