*Training Package: Hydrochloric Acid
Release*

Participant Guide

**NATIONAL HAZARDOUS
MATERIALS FUSION CENTER
TRAINING PACKAGE:
HYDROCHLORIC ACID
RELEASE**

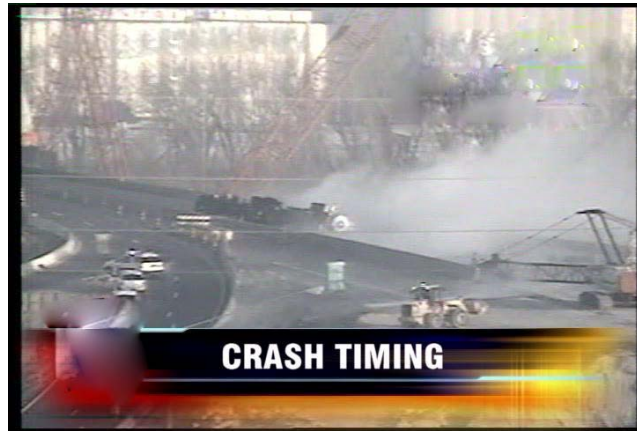
As a result of the crash, product began to leak down the highway creating a significant white cloud that began to envelop the area and move towards the east. The incident location was at the entrance to the downtown community through one of the most heavily traveled interstates in the

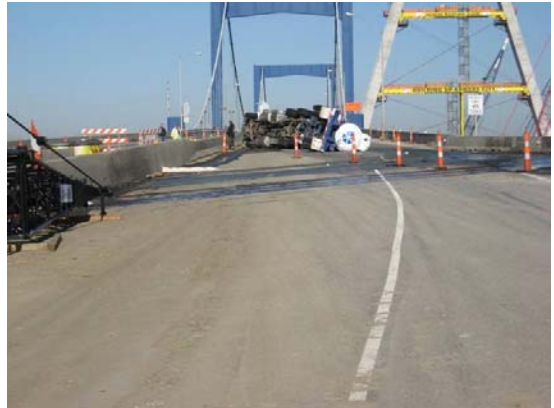
At approximately 0717 hours, local police and fire resources began to arrive on scene. The first arriving fire unit was a Battalion Chief (BC) accompanied by a District Safety Officer (DSO). Initial size-up reported the tractor trailer, later determined to be an MC-312, on its side leaking product and a driver trapped in the cab. They established command, donned Self-Contained Breathing Apparatus (SCBA) and initiated rescue operations. Simultaneously, police arrived from both jurisdictions, conducted a rapid scene assessment and began shelter in-place (initially) of occupants of the vehicles on the bridge and in the immediate area, quickly followed by evacuation of those persons from the hazard area. Agency Hazardous Materials (hazmat) units were also immediately on the scene as part of the initial dispatch and initiated preparations for a hazmat incident.

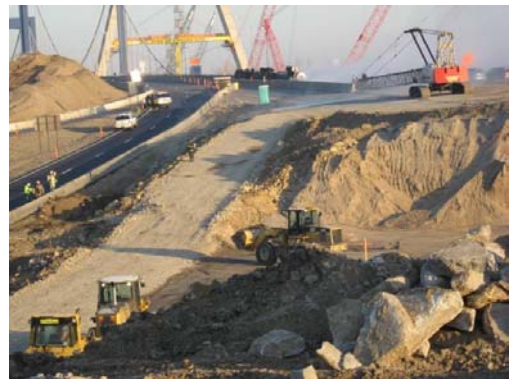
Local construction crews operating on and around the bridge approached a second arriving battalion chief with an offer for equipment and assistance. Directed by command, construction crews brought nearby earth moving equipment into the area and worked with fire personnel to erect three redundant dikes to capture and contain product and prevent sewer contamination. Sand and dirt—readily available due to the construction—were used to create the dikes. Diking the product resulted in pooling of the product, reducing the surface area of the spill and minimizing fuming and vapor production.

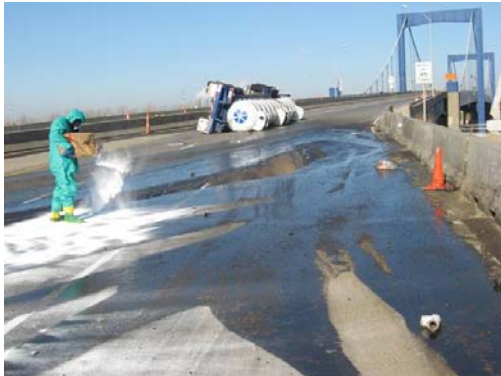
Cleanup efforts were affected by an independent contractor and representatives from the shipper. Contained pools of product were covered with soda ash and pumped into recovery vessels for

disposal. Air powered diaphragm pumps were also utilized to off-load the damaged trailer into a similar steel body, rubber-lined MC-312. After the vehicle was up-righted and removed, the bridge was re-opened to vehicular traffic. Cleanup efforts in the area continued for another day to remove contaminated soil from the area. In all, approximately 1,240 gallons (4,694 liters, which is roughly 12,000 pounds or 5,443.1 kilograms) of product was lost in the release.

Industry personnel revealed that the tank truck rupture likely occurred when the acid in the tank created a hammer effect by the force of the liquid in the tank rolling over when hitting the concrete barriers, resulting in failure of the rupture disc (set at 401 pounds per square inch). Additionally, the air pad valve was sheared off in the accident, creating an additional opening from which liquid could escape. (The air pad valve is the air inlet valve used to help “blow off” product when off-loading.) It is noteworthy that the vessel itself (manufactured in May, 1989) did not sustain any significant damage.
